REMOVAL ACTION PLAN

DEAD CREEK - SITE G

SAUGET, ILLINOIS

August, 1987

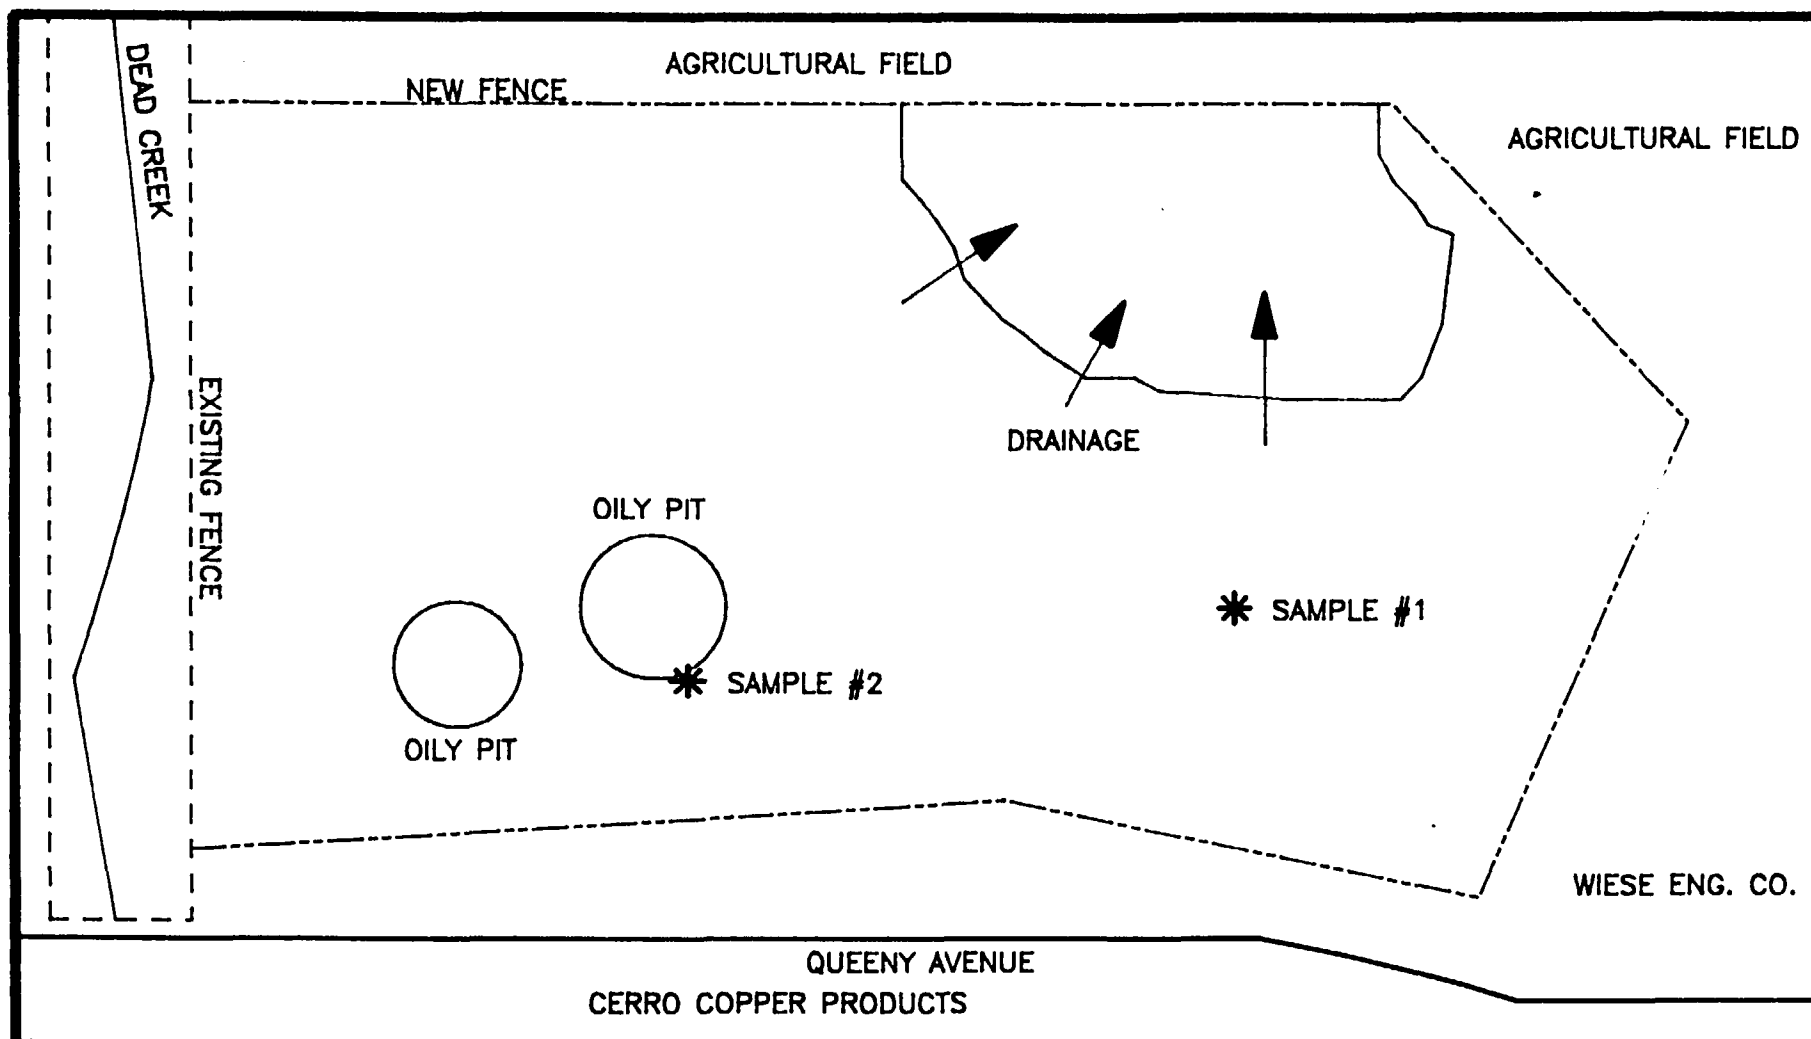
FIGURE 2
SITE MAP
DEAD CREEK, SITE-G
SAUGET, ILLINOIS

On March 4, 1987, Technical Assistance Team (TAT) members Curt Michols and Jeff Binkley accompanied U.S. EPA On-Scene Coordinator (OSC) Nick Longo on a SA at the Site G area. Upon arrival at the site, the TAT members and OSC met with Dan Sewel and Kevin Phillips of E&E, and Bob Johnson (IEPA consultant). TAT, OSC, IEPA, and E&E representatives proceeded to walk around the site. The TAT observed discarded construction materials strewn across a large portion of the site. In the east central and northeast areas of the site were several small pits containing oily and tar-like waste. The pits also contained corroded drums. The western portion of the site had a mound which also contained corroded drums. A depression just south of the mound appeared to receive the runoff of a large portion of the site. The northern side of the site, which borders Queeny Avenue, appears to be subject to random dumping of various types of non-hazardous materials. It was noted that the site was not fenced and was easily accessible (See Attachment A - Photographs, and Figure 2).

Upon completion of the initial site surveillance, the TAT proceeded to collect two surface soil samples to be analyzed for PCP and PCBs (Figure 2 sample locations).

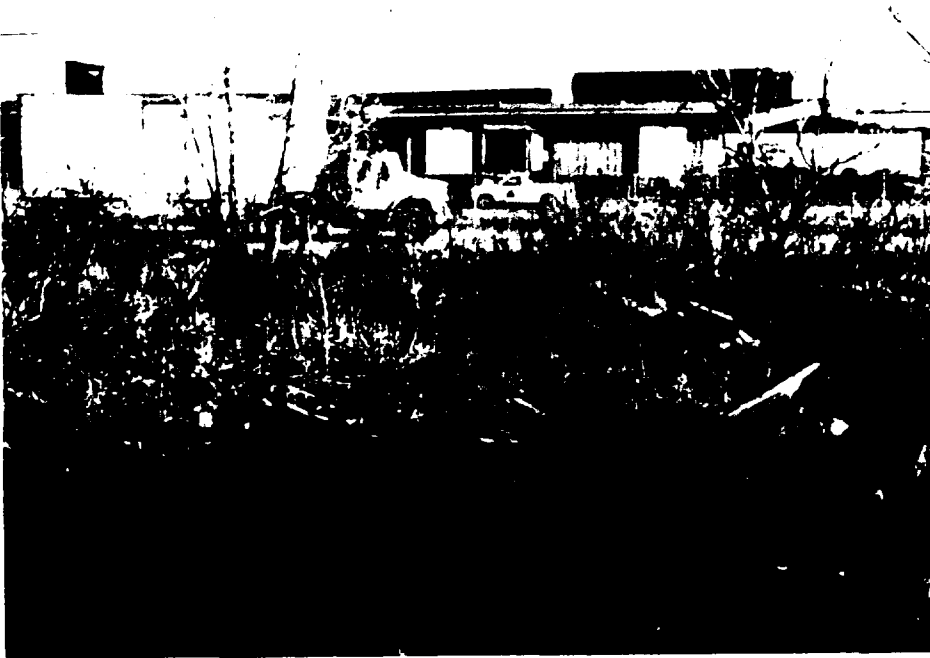
Photograph #5
 Dead Creek-Site G, Sauget, Illinois.
 Oily pit in northeast corner of site.
 Photographer: Nick Longo
 Witness: Jeff Binkley *JB*
 Date: March 4, 1987
 Time: 0755

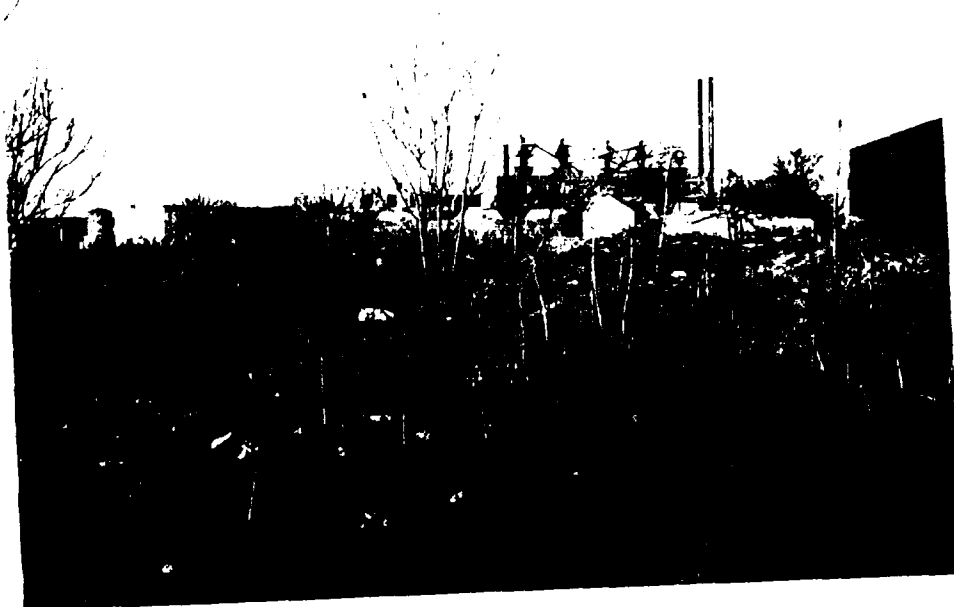
Photograph #7

Non-hazardous debris scattered on surface along
Queenie Avenue.

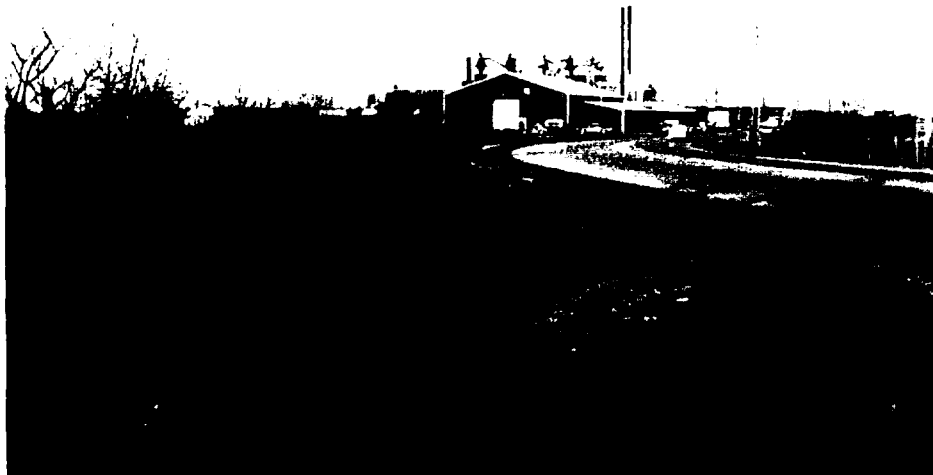
Photograph #1

Dead Creek-Site G, Sauget, Illinois.
Northern edge of site, bordered by Queeny
Avenue.

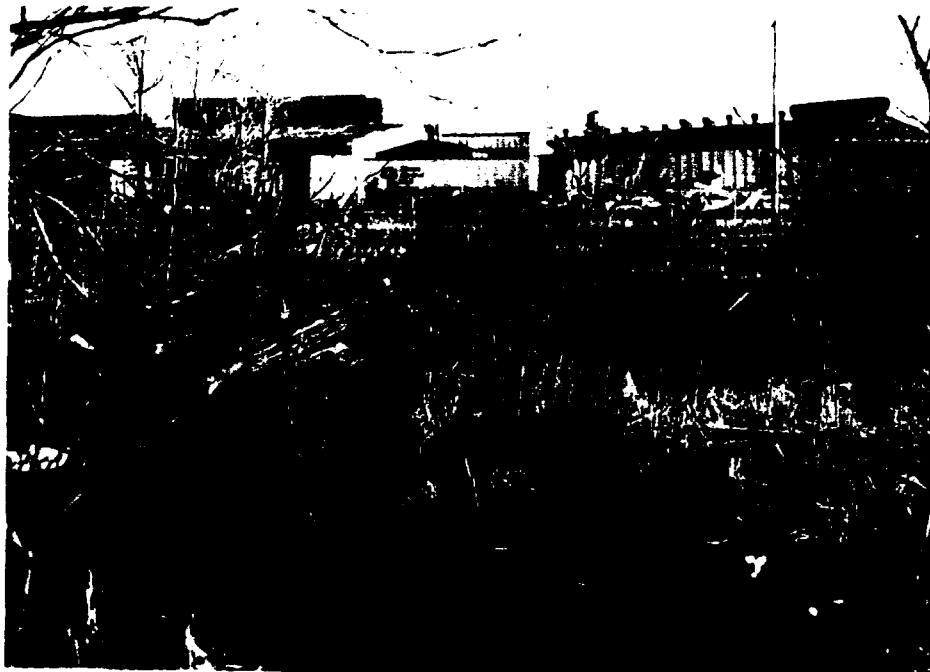
Photograph #2

Site investigations have revealed the presence of highly contaminated soils and oily pits at this site. High levels of PCBs and PCP have been documented in surface soils. Also, there are exposed corroded drums which would be readily accessible to people or wildlife. The possibility of off-site pollutant migration via surface runoff would expand the area of potential exposure. No restriction of access to the area is in place, increasing the potential for direct contact with the substances.

Dead Creek-Site G, Sauget, Illinois.
Drums strewn about surface near center of site.

Due to the threat of direct exposure to the hazardous substances documented on-site, the TAT recommends that site access be restricted immediately by installing a fence around the site. In addition, the TAT recommends that the site be capped upon completion of the air monitoring phase of IEPA's RI/FS to mitigate migration of contaminants off-site.
